# FORTIFIED ESTATE FORCED ENTRY TEST REPORT

SD-STD-01.01 REVISION H TESTING ON FE15 DOOR ASSEMBLIES

R5588.01-119-12 R1

**Product Type:** *FE15* Door Assembly

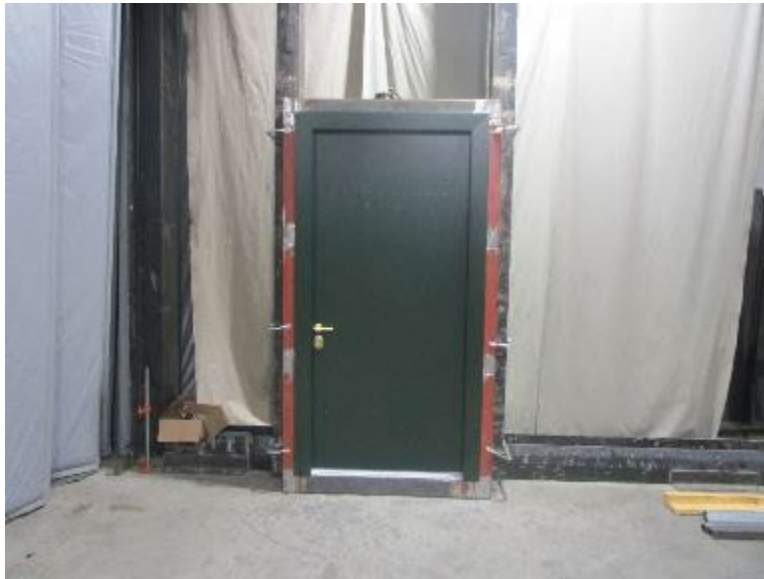
**Photo No. 3**  
**Starting Condition of Outswing Door (Attack Side)**

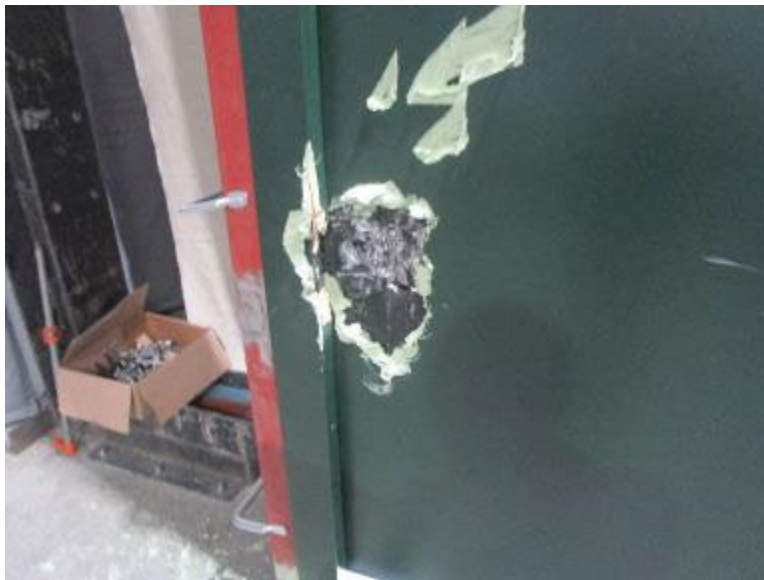
**Photo No. 4**  
**Final Condition of Lock Side Location of Inswing Door (Attack Side)**

ATTACK LOCATION	ATTACK RESULT
Lock Side	The assault team was unable to create an opening large enough to pass the 12 in by 12 in by 8 in rectangular solid or 12 in by 12 in cylinder representing contraband during the 15-minute attack
Hinge Side	
Door Panel	The assault team was unable to create an opening large enough to pass the 12 in by 12 in by 8 in rectangular solid or 12 in by 12 in cylinder representing contraband during the 15-minute attack; removed the fiberboard outer layer and created an 18 in by 4-1/2 in hole in the front of the door panel

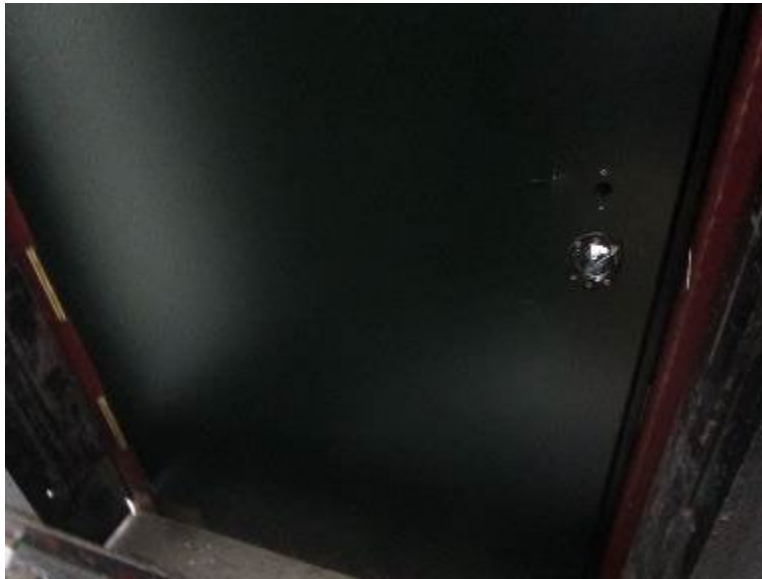
**Photo No. 5**

**Final Condition of Lock Side Location of Inswing Door (Protected Side)**

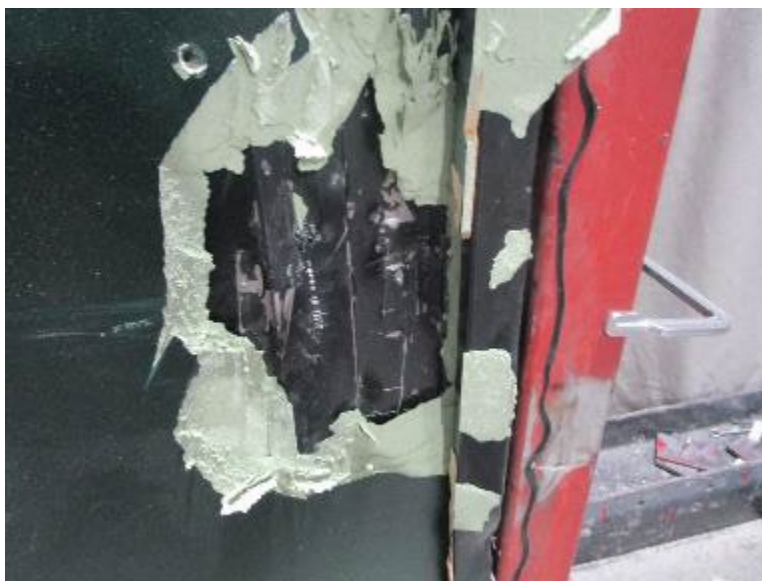
**Photo No. 6**

**Final Condition of Hinge Side Location of Inswing Door (Attack Side)**

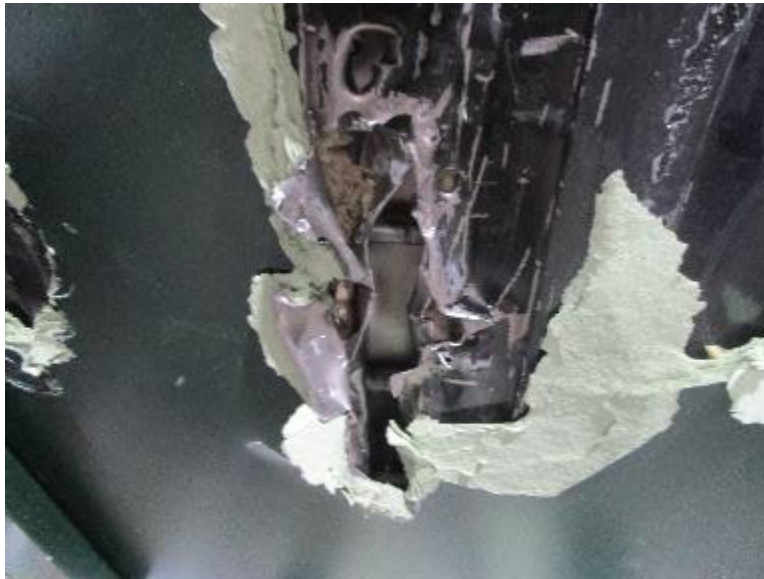
**Photo No. 7**

**Final Condition of Door Panel Location of Inswing Door (Attack Side)**

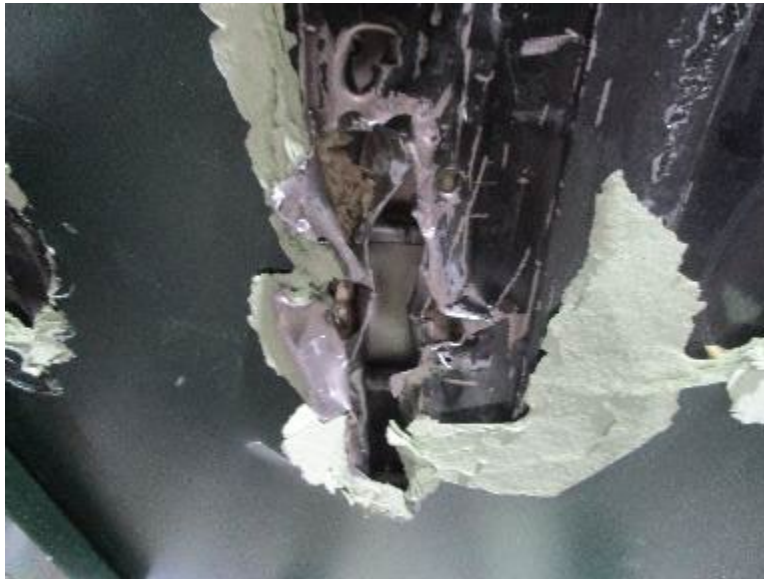
**Photo No. 9**

**Final Condition of Door Panel Location of Inswing Door (Attack Side)**

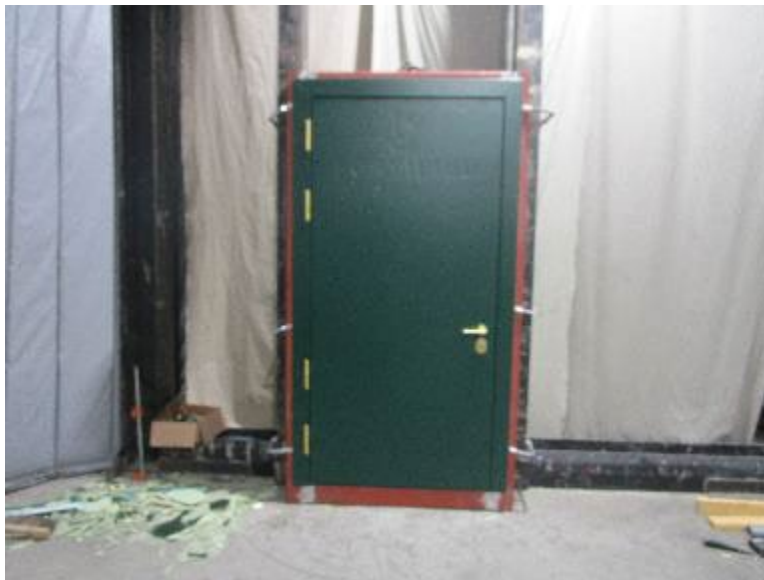
**Photo No. 10**

**Starting Condition of Outswing Door (Attack Side)**

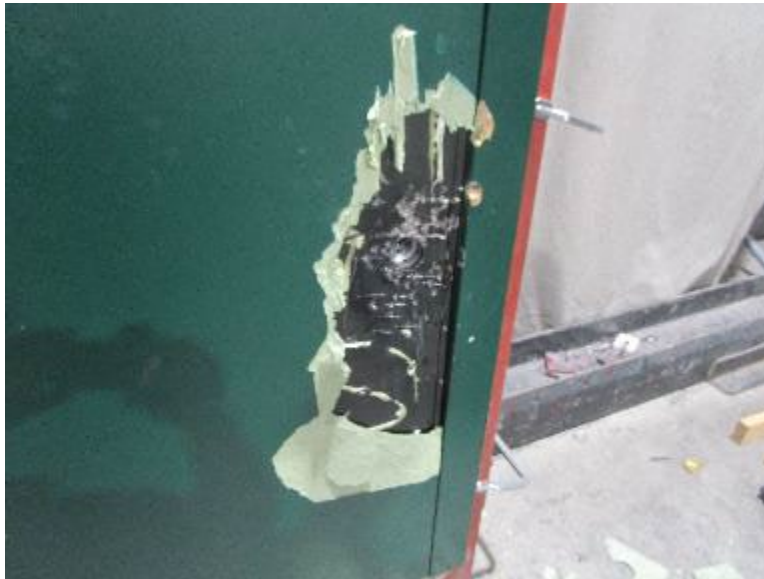
**Photo No. 11**

**Final Condition of Lock Side Location of Outswing Door (Attack Side)**

ATTACK LOCATION	ATTACK RESULT
Lock Side	The assault team was unable to create an opening large enough to pass the 12 in by 12 in by 8 in rectangular solid or 12 in by 12 in cylinder representing contraband during the 15-minute attack
Hinge Side

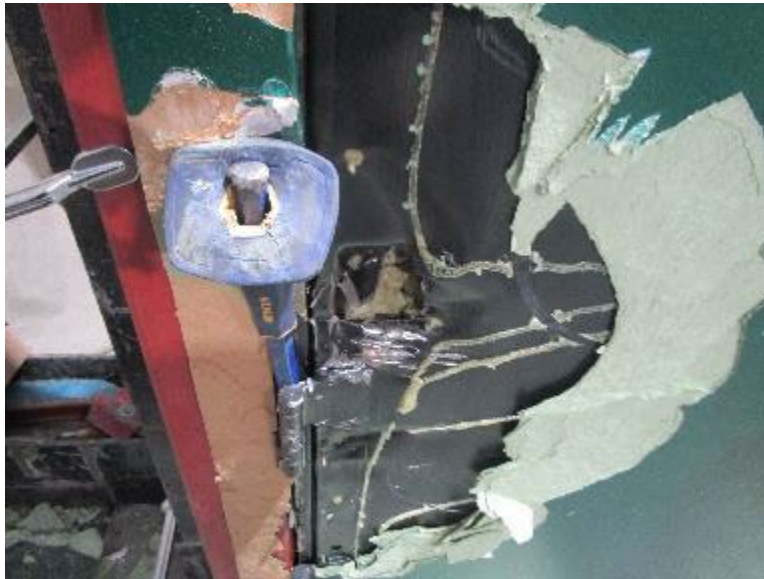
**Photo No. 13**

**Final Condition of Hinge Side Location of Outswing Door (Attack Side)**

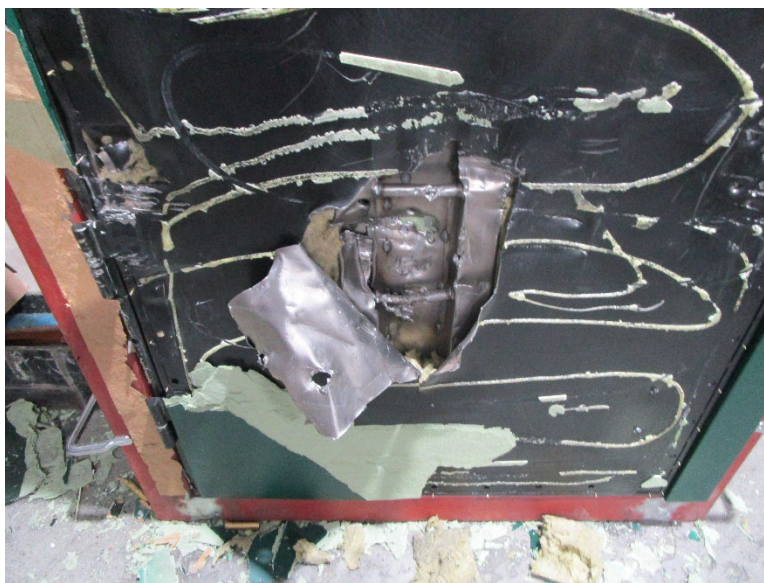
**Photo No. 14**

**Final Condition of Door Panel Attack Location of Outswing Door  
(Attack Side; 15 Minutes of Attack)**

ATTACK LOCATION	ATTACK RESULT
Door Panel <sup>1</sup>	The assault team was unable to create an opening large enough to pass the 12 in by 12 in by 8 in rectangular solid or 12 in by 12 in cylinder representing contraband during the 15-minute attack; removed the fiberboard outer layer and created a 19-1/2 in by 10 in hole in the front of the door panel. The assault was continued for an additional 15 minutes where the assault team was still unable to create an opening large enough to pass the 12 in by 12 in by 8 in rectangular solid or 12 in by 12 in cylinder representing contraband; the hole size was increased to 21 in by 14-1/2 in on the attack side and a 12-1/2 in by 8 in hole was created through the door on the protected side

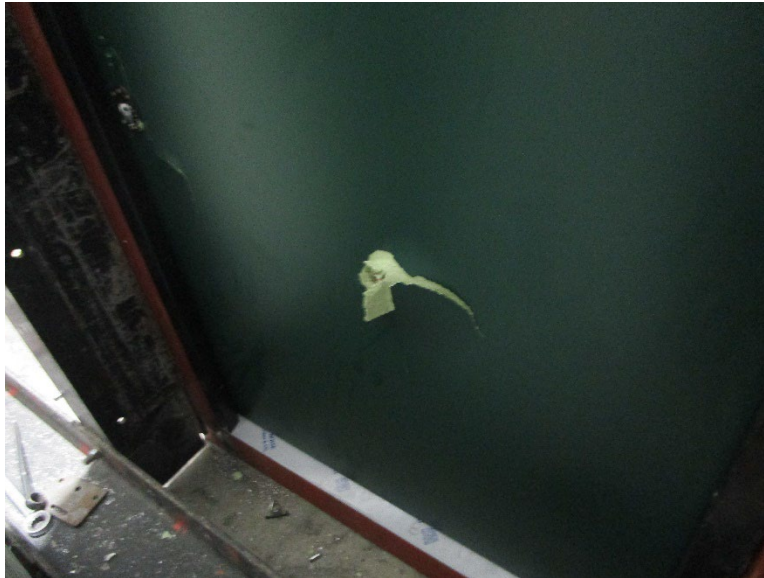
**Photo No. 15**

**Final Condition of Door Panel Attack Location of Outswing Door  
(Protected Side; 15 Minutes of Attack)**

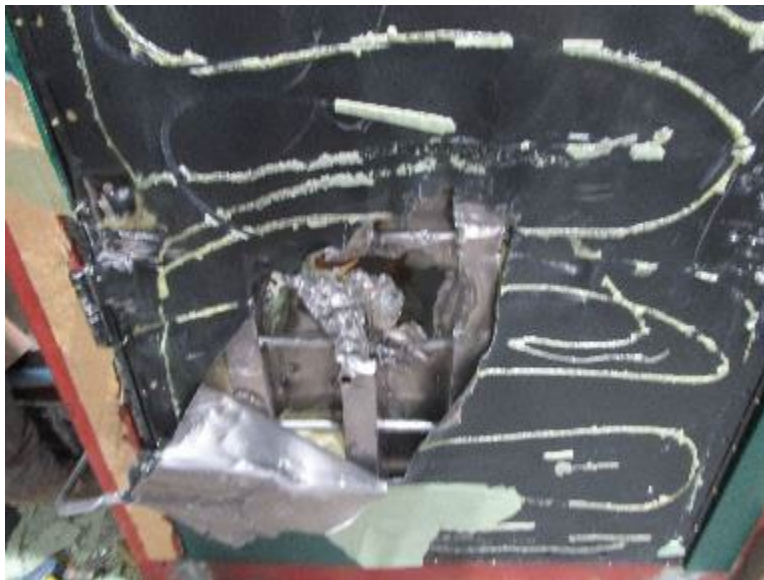
**Photo No. 16**

**Final Condition of Door Panel Attack Location of Outswing Door  
(Attack Side; 30 Minutes of Attack)**

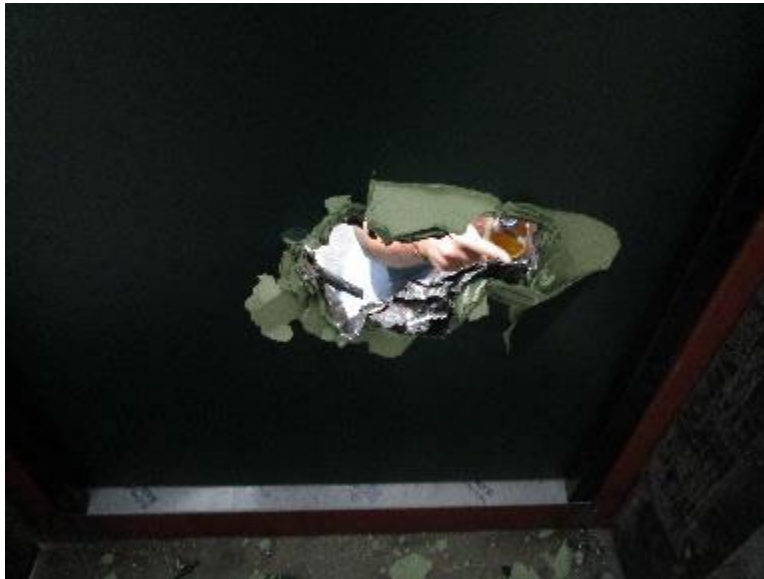
**Photo No. 17**

**Final Condition of Door Panel Attack Location of Outswing Door  
(Protected Side; 30 Minutes of Attack)**
